CONDITION ASSESSMENT AND RECOMMENDATIONS

# 200 BLOCK OF SOUTH JESSUP STREET

PREPARED FOR  
CLIFF AND LYNN LANDES

OCTOBER 2010

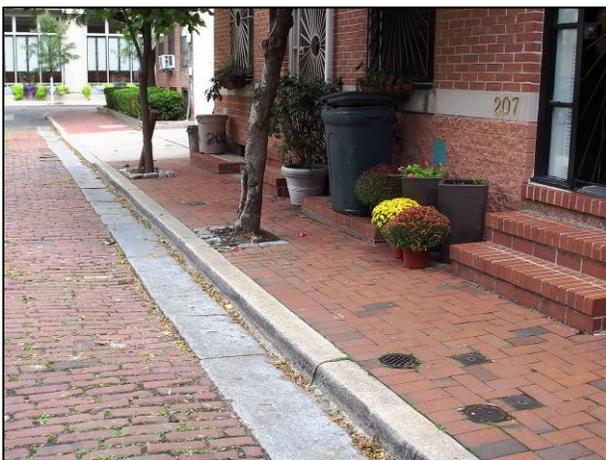
As mentioned, original granite curb units are present on only approximately 65% of the street. Aside from areas where the units are missing completely, there is a large stretch at the northeast end of the street where the original granite has been replaced with a concrete curb (Image 4). Spot replacements have also been made using newer granite units, notably at the Latimer and Irving Street intersections as well as at the southern end of the block (Image 5). The overall condition of the extant granite curb units can be categorized as fair, as many units are extremely eroded. The worst examples are the curb units along the parking area which receive the most amount of wear and tear from vehicles (Image 6). These units exhibit not only heavy erosion, but also extensive cracking. In some areas where the curb units have eroded or sunk below the level of the brick sidewalk paving, efforts have been made to fill the resulting voids with mortar (Image 7). Some areas of “erosion” appear to be manmade, an effort to create a path for water to drain off the sidewalk. Other conditions noted include units which are sunken/out of plane, exhibit cracks and areas of loss, and which are partially covered over with concrete (Image 8). Additionally there are visible abrasions on the stone surface which are the result of municipal snow removal equipment (Image 9). The curb stones are in the worst condition of the three paving materials largely because they are subjected to the most deterioration mechanisms including foot traffic and water runoff from the sidewalks. It should also be noted that during the survey, MCC observed a garbage truck backing down the street to pick up residents’ trash. Because the street is too narrow to properly accommodate the vehicle, one side of the truck was riding along atop the curb (Image 10). At 6 ½ ft. wide, the street is too narrow to accommodate most modern pickup trucks and utility vans which are forced to drive on one curb or the other. This activity is likely contributing to the ongoing degradation of the granite curb units.

**Image 4:** Concrete replacement curb, northeast end of street

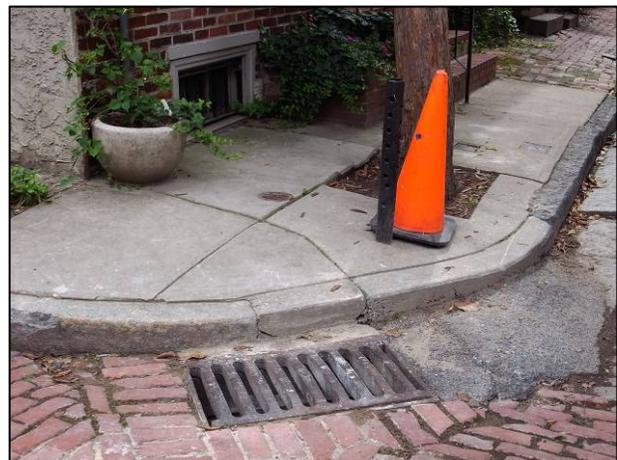
**Image 5:** New granite replacement curb, intersection of South Jessup and Irving Streets

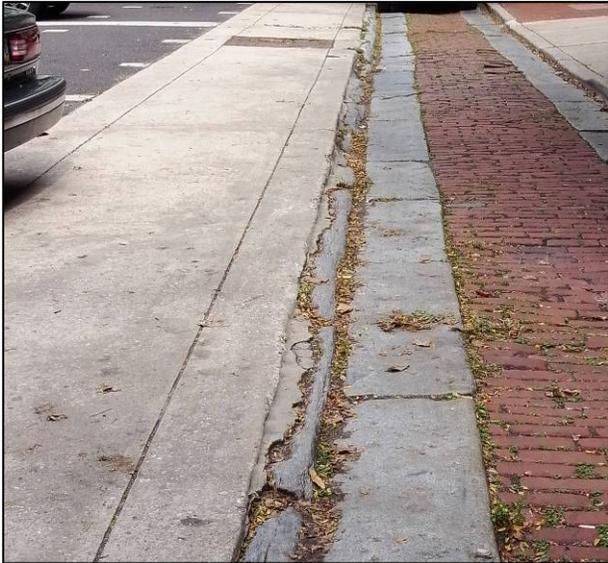
**Image 6:** Severely eroded curb stones along parking area, northwest end of street

Erosion – Curbs stones exhibit the highest levels of erosion. Extremely eroded units (those which have been worn down below the level of the sidewalk) could be excavated and reset higher up so they are flush with the sidewalk.

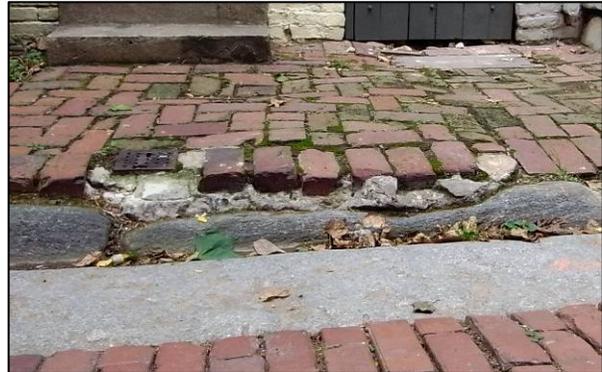
**Image 7:** Example of a void created by eroded curb stone which has been filled with mortar

Sunken/Heaved Areas – Curb stones which are out of plane should be excavated and reset so that they are properly aligned with the edge of the sidewalk paving material. This method is preferable to simply filling existing voids with mortar. Sections of the street where the gutter stones and/or brick pavers are heaved or sunken should be reset in order to promote proper drainage and prevent tripping hazards. In some locations, resetting may involve removal of existing original and/or replacement paving materials and either flattening out or else backfilling the foundation materials. Repaired areas would then be repaved either with the original materials or else in kind replacement materials. In other locations, individual masonry units may simply need resetting. Areas which should be considered for resetting include the intersection of South Jessup Street and Latimer Street, the intersection of South Jessup Street and Irving Street, and the section of the street between houses 227 and 229. For locations where brick pavers are being reset it is recommended that they are set in a bed of sand rather than a concrete slab and that the joints are filled in with soil rather than mortar. This will prevent the likelihood of recurring heaving due to trapped moisture and freeze thaw cycles and will also allow select areas of paving to be removed without being damaged during underground utility maintenance.

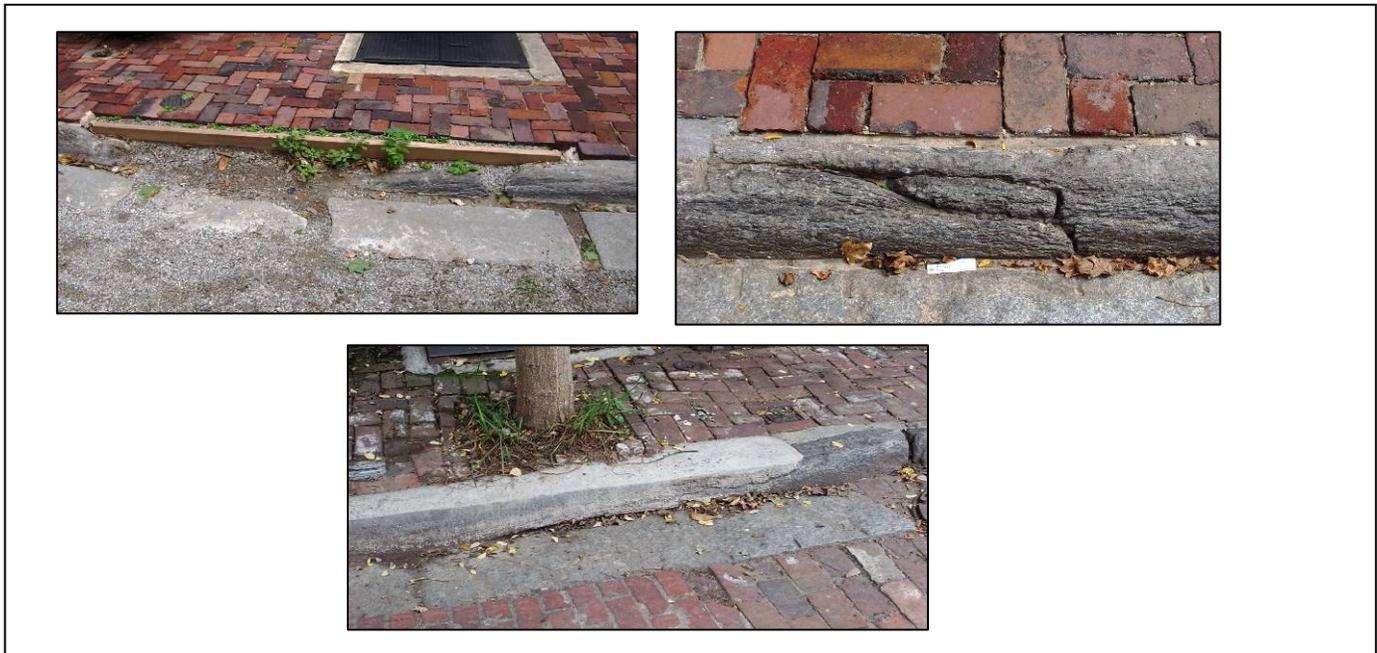
**Image 8:** Clockwise from left: sunken curb stone, cracked curb stone and curb stone partially covered by cement

Cracks – Existing cracks in curb stones and gutter stones could be cleared of debris and filled with a compatible patching material to prevent infiltration of water and continued expansion of the cracks. Through-unit cracks could be excavated and pinned together with threaded stainless steel rod and epoxy. Neither of these repairs is considered essential.

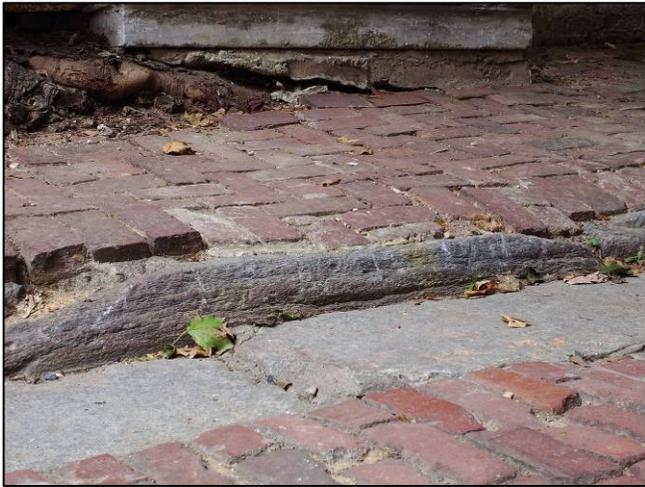
**Image 9:** Abrasions on surface of curb stone due to municipal snow removal equipment

Modification of Traffic Flow – Very few vehicles travel on South Jessup Street, especially since it does not connect through between Locust Street and Spruce Street. Among the exceptions are municipal snow-clearing vehicles, garbage collection vehicles and large contractor pickup trucks. These vehicles are contributing to the degradation of the historic paving materials. Consideration might be given to limiting heavy vehicles on the street and developing alternative snow removal methods and block-wide efforts to place trash at the corner of Locust Street for collection.

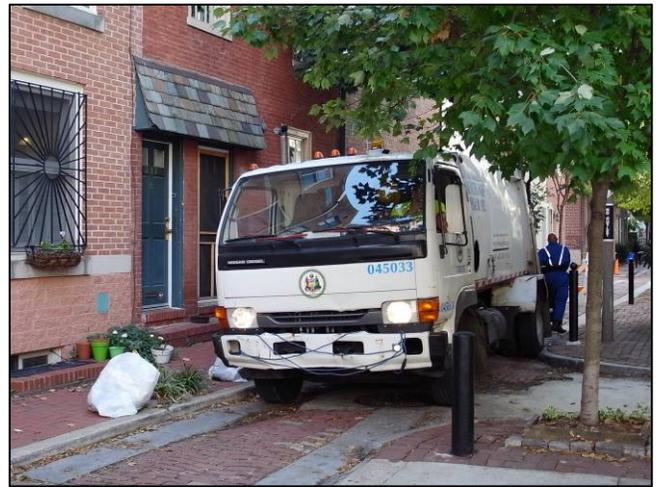
**Image 10:** Wheels of a garbage truck ride along top of curb stones

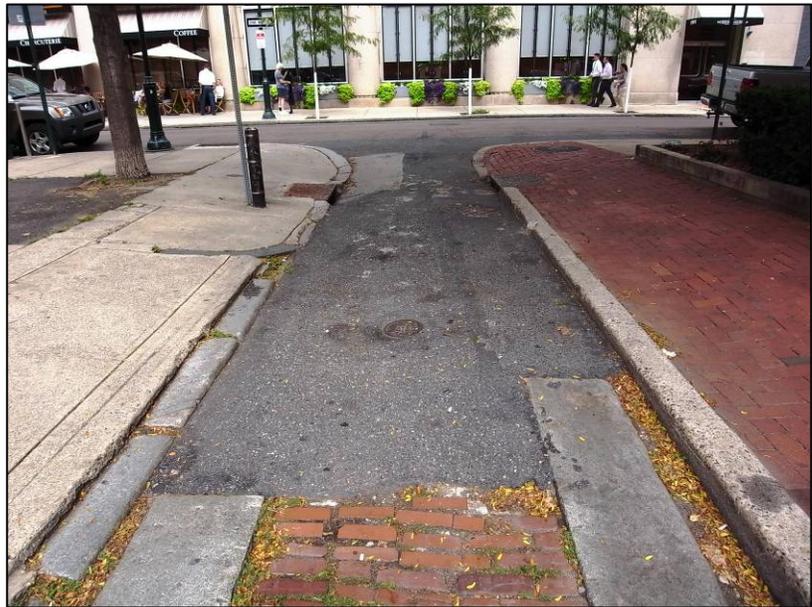
The granite gutter stones are in significantly better condition than the curb stones. A 30' section of the street just south of Locust Street is the only significant area of original material loss. This section has been completely paved over and is largely devoid of any historic paving materials (Image 11). Additionally, there are a few gutter stones near the parking area which appear to be replacement units. Of the existing original units, observed conditions include those which are sunken/out of plane, have been partially covered by other paving materials, and those which cracking. Cracks range from hairline to through cracks which have resulted in a complete break in the unit. Almost all units exhibit some level of surface pitting and/or minor losses on the surface or corners.

**Image 11:** Section of South Jessup Street just south of Locust Street which largely devoid of any historic paving materials

Replacement of missing historic materials on South Jessup Street would create a more visually unified historic street. The two primary sections which should be addressed are the 30' section of the block which

extends just south of Locust Street and the intersection of South Jessup Street and Latimer Street. Both of these locations have been paved over with asphalt. This asphalt should be removed and the curbs units, gutter blocks and brick paving should be replaced in kind. Residents of the block not only have a stockpile of historic McAvoy Blocks which could be used for repaving the street, but also know of another location where historic paving brick can be obtained. It is possible that some historic material is present below the asphalt. These materials are not necessarily salvageable, though an attempt should be made to uncover and reuse them. In kind replacements should also be made at select locations including any areas with missing paving materials as well as locations with the most strikingly incompatible replacement materials. These include the section of concrete curb and sections of brick which have been repaired with concrete, contemporary brick, or brick fragments.

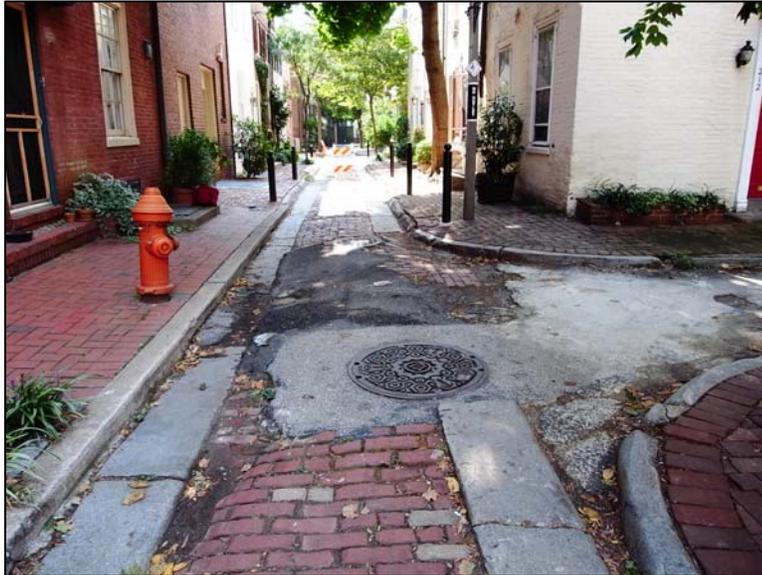
**Image 12:** Intersection of South Jessup and Latimer Streets where original paving materials have been removed/paved over

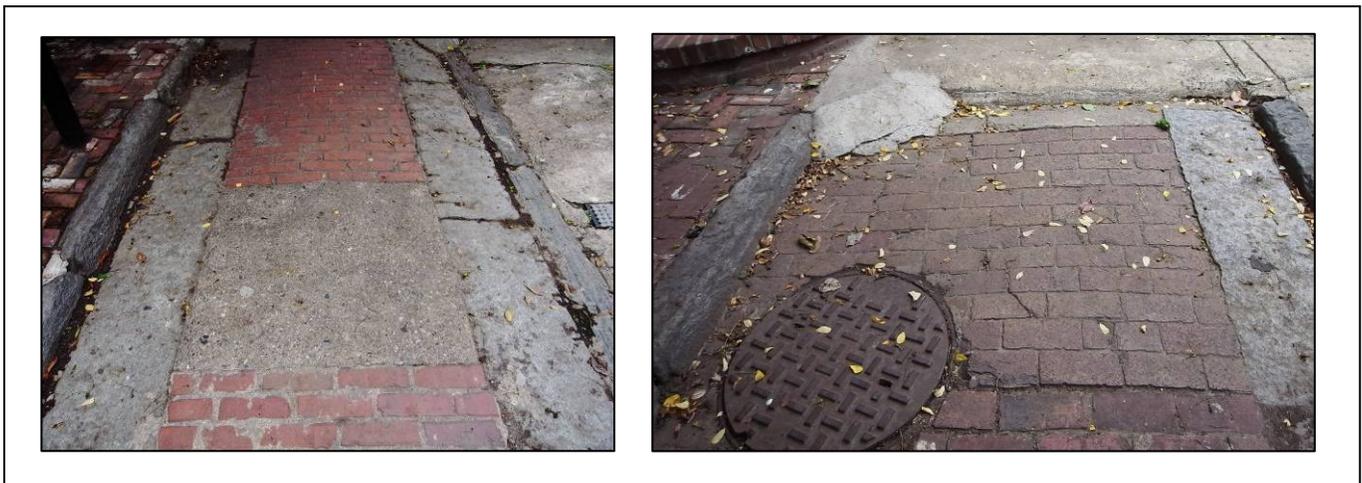
**Image 13:** Left: section at south end of South Jessup Street which has been repaved with concrete. Right: section at south end of South Jessup Street which has been repaved with contemporary brick.

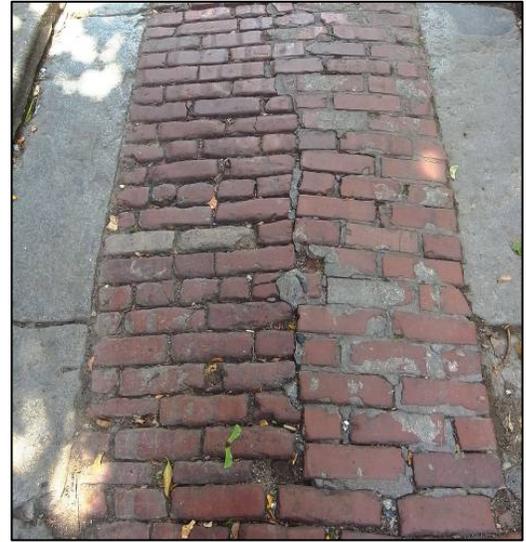
**Image 14:** Section of replacement brick which includes mismatched brick and brick fragments

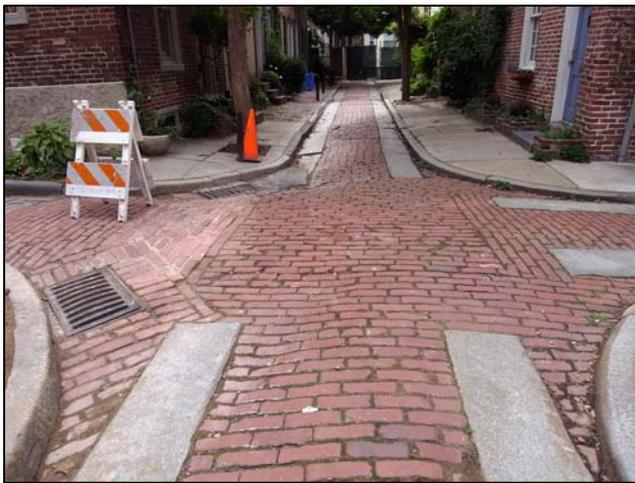
The most significant condition observed is the unevenness of the paving which includes sections which are either heaving or sunken. The most noteworthy of these are near the intersection with Latimer Street (Image 12), at the intersection with Irving Street (Image 15) and between houses 227 and 229 (Image 16). In most cases, this condition appears to be the result of disruptions from previous repairs and/or poor drainage including open joints. It is also possible that sunken areas are due to erosion which has occurred below the street. The paving at the intersection with Latimer Street has been completely covered or replaced with asphalt paving. There are two utility access holes at this intersection and the original paving was clearly removed during some previous maintenance work. This maintenance dates from at least 1993 as evidenced by a photograph from that period. The sunken area between houses 227 and 229 appears to result from run-off from the buildings' downspouts and the sloping of the brick sidewalk towards the street. These conditions have also caused erosion and misalignment of the curb and gutter stones at this location. Other observed conditions include protruding individual bricks, spalls, cracks and small losses.

**Image 15:** Section of uneven paving at the intersection of South Jessup and Irving Streets

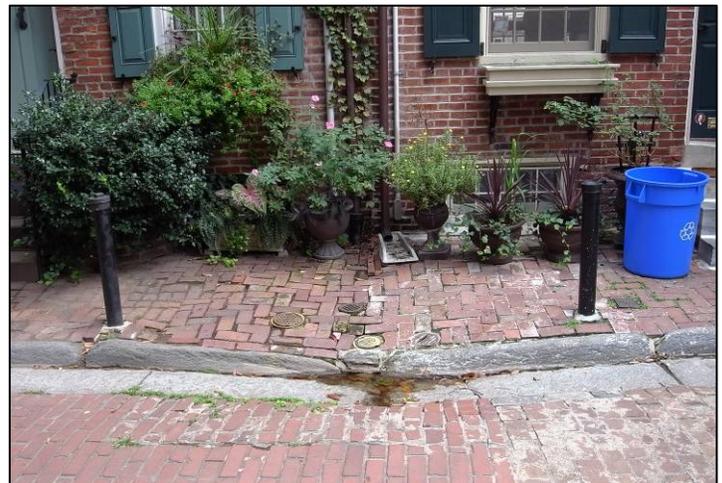
**Image 16:** Section of sunken paving between houses 227 and 229
